No.: SM 7 - 2009

Serious safety issue concerning life buoys

Life buoys fill up with water and sink when deployed in water.

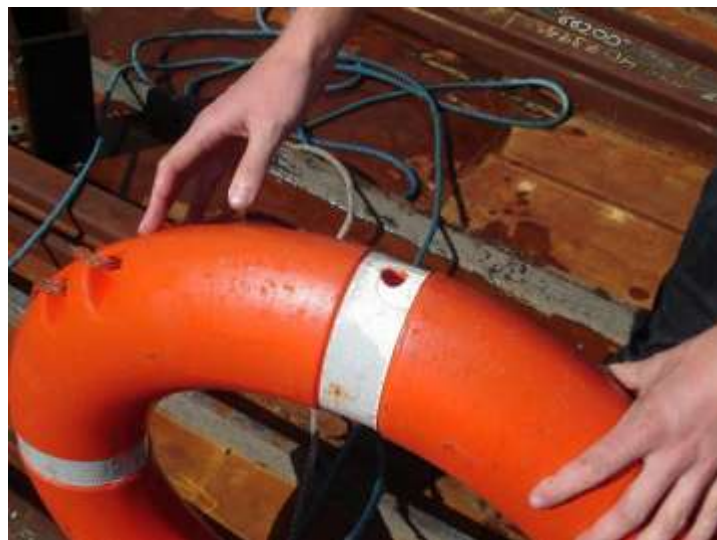
Photo: Swedish Transport Agency

The cause being an event in Sweden where suspicion arose when checking life buoys and finding them heavier than normal. Upon further inspection it was discovered that the life buoys were filled with water and that water was dripping out in the area around the reflective tape. There was also a visible crack on one of the reflective tapes, and when pushed on, a 15mm hole appeared. Several litres of water were subsequently drained from this hole. When the life buoys were thrown into the water, they sank. The issue seems to be related to the foam inside the buoy. The foam does not fill out the available space inside the buoy and leaves room for water to ingress. The cause of this foam related problem is not known at present. The inspection revealed that all life buoys (which had been bought in 2004) on board the vessel had the same problem.

The NMD urges ship-owners, ship crews, harbours, marinas, and others in possession of life buoys, to inspect their life buoys immediately in order to verify whether the same issues apply to their life buoys, and make sure that the area surrounding the reflective tape is inspected thoroughly.
