EARLY SAFETY ALERT No: 01/2018

Non Authentic Test Certificate for mooring rope

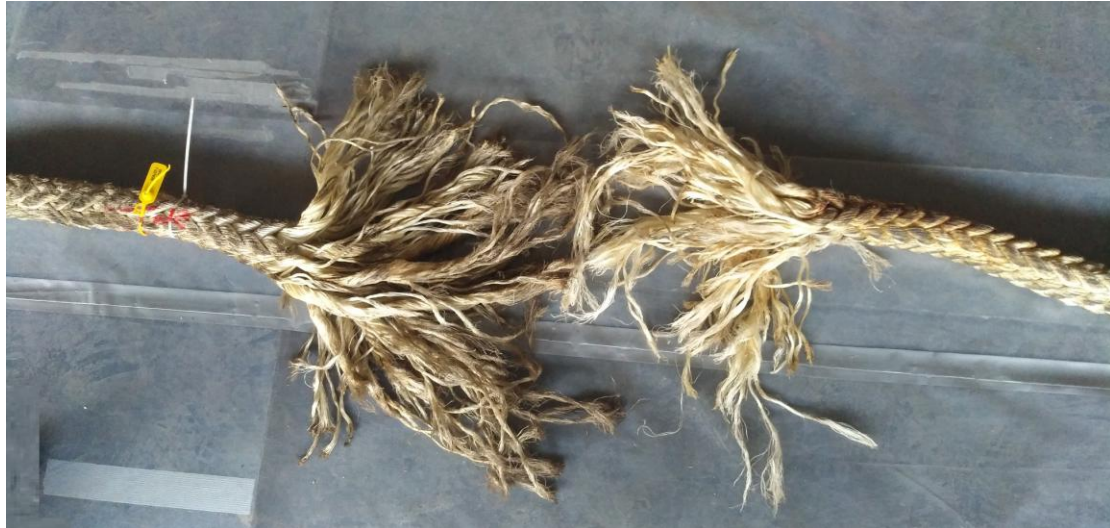
Figure no 1: Both parts of the mooring line after its breakage.

During the casualty, a mooring line of a ship parted. The breakage areas on both of the parts after the casualty are displayed in Figure no 1.

In addition to the above, the parted mooring line was not permanently marked in order its positive identification to be feasible.
