## Severe defect on fire hoses

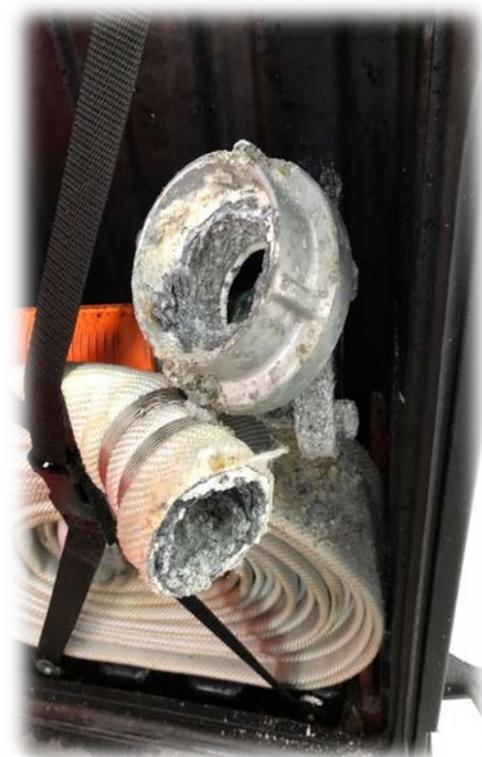
During inspection of fire protection equipment on board a relatively new fishing vessel, serious defects were found on several fire hoses with nozzles.

Corrosion had caused the coupling to separate from the fire hose.

Such damage renders the fire hose useless in the event of fire. Corrosion of such a character may also cause injury to personnel if the coupling breaks down when pressure is applied to the hose.

The main cause is that fire hoses are fitted with couplings that are not of seawater resistant material. Corrosion has advanced to the point where the coupling is corroded through. This has not been detected by the crew on board.

When installing this type of equipment, make sure that the equipment is approved for a maritime environment. The Norwegian Maritime Authority also wants to point out the importance of regular inspections and maintenance of fire hoses to ensure that the equipment is ready for use at all times. Fire drills must also be carried out according to the stipulated deadlines for the relevant vessel type. Testing of fire hoses should be included as a natural part of such drills.
