Sjøfartsdirektoratet
Norwegian Maritime Authority

FOCUS ON
RISKS

2017

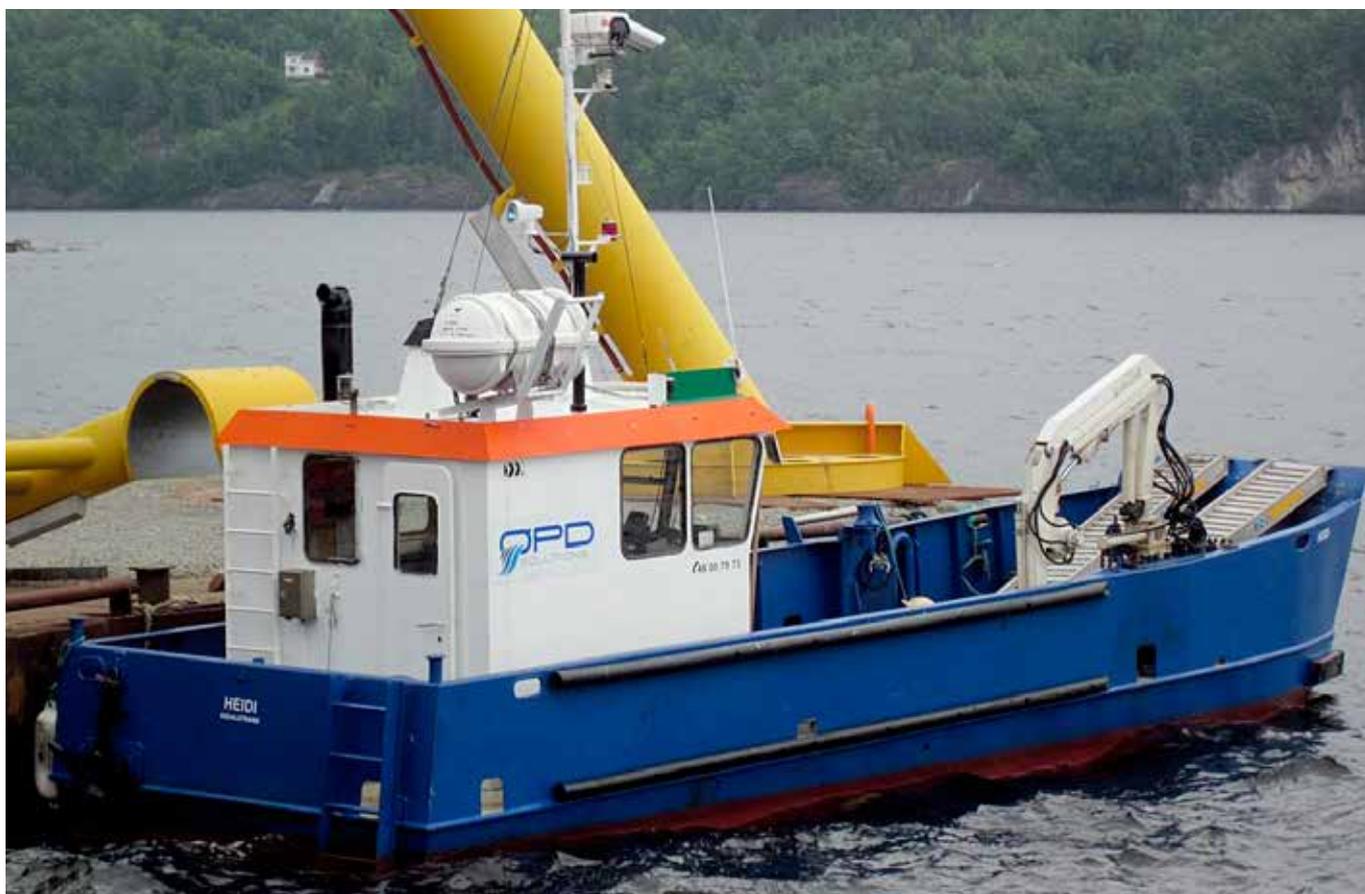
Heidi foundered in February 2015: Poor stability lead to capsizing

The workboat Heidi broke free from its mooring while they were preparing a diving operation. The diving foreman drove the vessel in a circle while awaiting a new mooring line. Estimates from the Accident Investigation Board Norway (AIBN) show that the total deck cargo on board caused the vessel's stability to be very poor to begin with.

In addition, a low forward freeboard resulted in water flooding the deck, which in turn penetrated the hull through damage to the gooseneck and non-tight hatch covers. The bilge water was not drained in a satisfactory manner. In practice, this meant that the vessel's stability and back-up stability was non-existent. Heeling forces from the use of the rudder combined with sideways movement of bilge water contributed to capsizing and foundering.

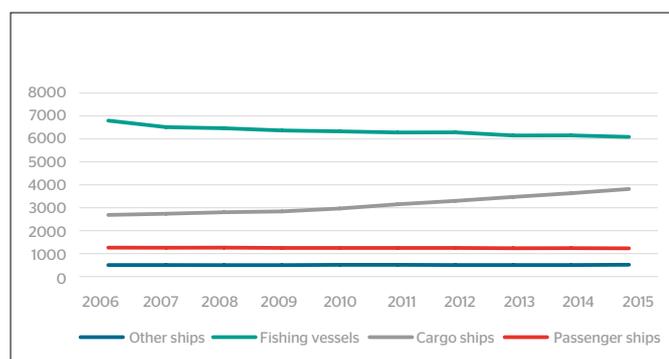
Figure 1: Development of number of commercial vessels NOR/NIS 2006-2015

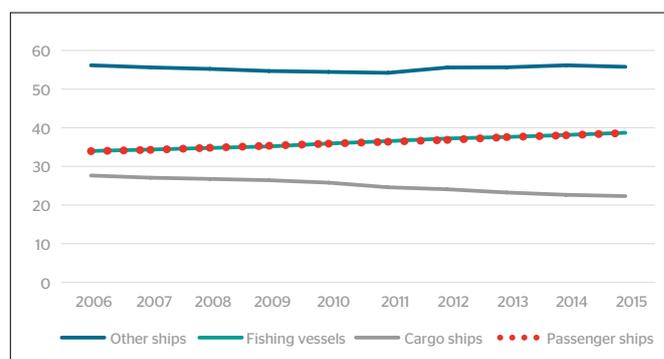
Figure 2: Development in average age per vessel group

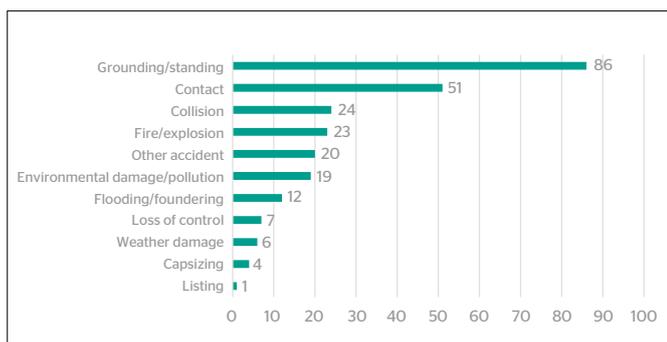
Figure 1: Number of Norwegian-registered commercial vessels involved in casualties, 2015

Of the 253 vessels in total that were involved in casualties in 2015, around 34% were groundings, while 20% were contacts and 9% were collisions. In other words, navigation-based occurrences constituted 63% of all vessel occurrences in 2015. An overview of the number of ships involved in the various casualty events is found in figure 1.

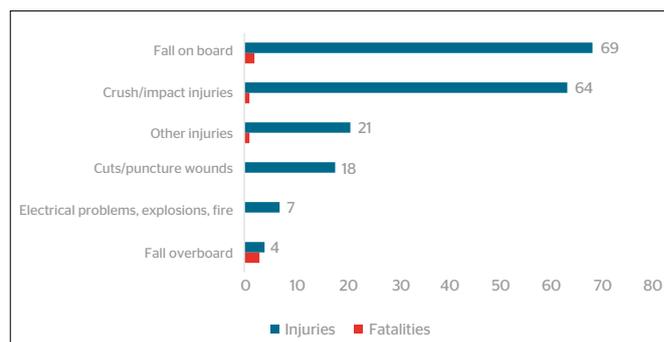
Figure 2: Number of injuries and fatalities on Norwegian commercial vessels, 2015

The NMA registered a total of 190 injuries in 2015. Whereof 7 were fatalities and 183 were injuries. As before we have limited ourselves to incidents which entail work absence exceeding 72 hours for crew members, or incidents that involve passengers or other persons on board the vessel. Six of the incidents in 2016 were a result of casualties with a ship and 184 were a result of occupational accidents. Compared to 2014, this is a reduction of four injuries. The average number of injuries per year on Norwegian commercial vessels the last five years is 197.

Most injuries were impact/crush injuries and injuries from falls on board. In total, these types of injuries constitute almost 71% of all injuries in 2015. Among the fatalities, three were caused by falls overboard, two were falls on board, and one was caused by crush/impact injuries. In addition, we have registered one fatality as «other occupational accident», this occurred in connection with the loss of a ship. Six of the seven fatalities overall were persons working on board the ships. The majority of these were at work when the accident occurred.
