Marine casualties 2000 - 2010

Strategic Safety Department 2011

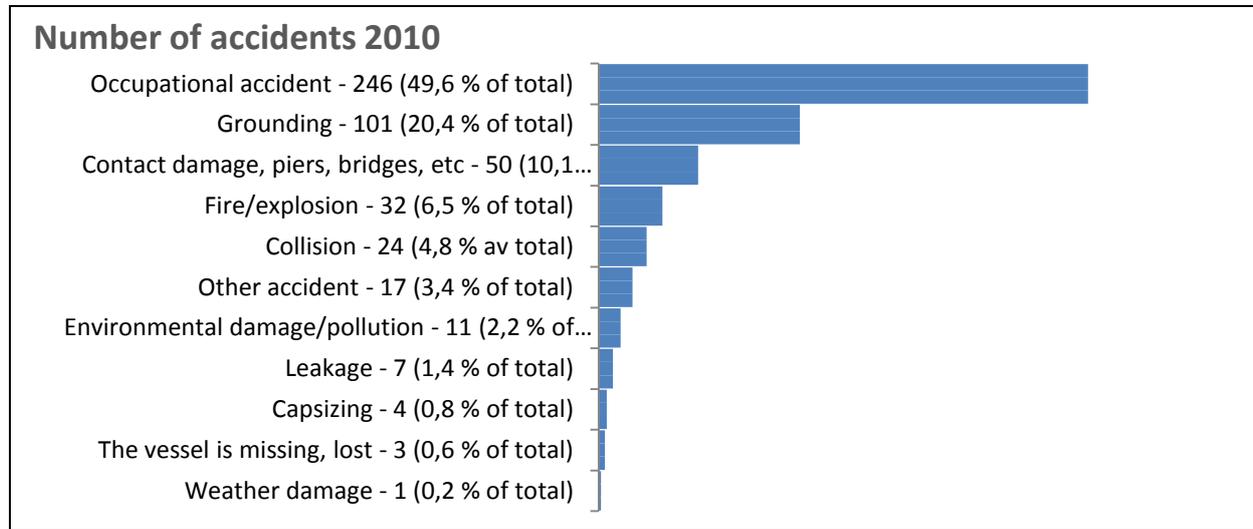
A total of 495 accidents were recorded in 2010. Figure 2.1 shows that this is a slight decrease (2%) compared to 2009. About half of the reported accidents are occupational accidents.

Figure 2.1 Accidents in 2010 by type of accident

Other accidents in this chart represent incidents such as those related to towing, mooring operations and lifting equipment.

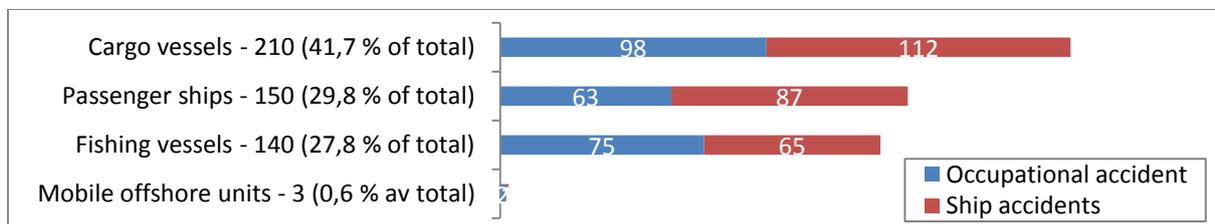
Figure 2.2 shows accidents in 2010 by main groups of vessels.

Figure 2.2 Accidents per vessel and accident group in 2010 (number of incidents per vessel involved)

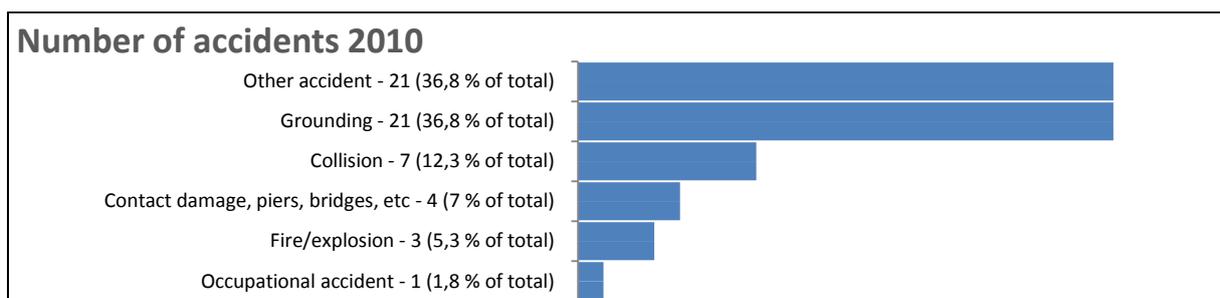
We see a decrease in the number of near accidents reported in 2010 compared to previous years. Introduced by a 2008 amendment of the Norwegian Maritime Code, requirements for reporting near accidents are still relatively new. Most near accidents that are reported are related to engine failure or other technical problems with the vessel.

Figure 2.3 Near accidents in 2010 by type of accident

Other accidents in this list include incidents such as ropes in propellers, engine failure, technical problems with critical equipment and the like. Such incidents are recorded when they are considered to have a potential for disaster if they had occurred under slightly different circumstances.

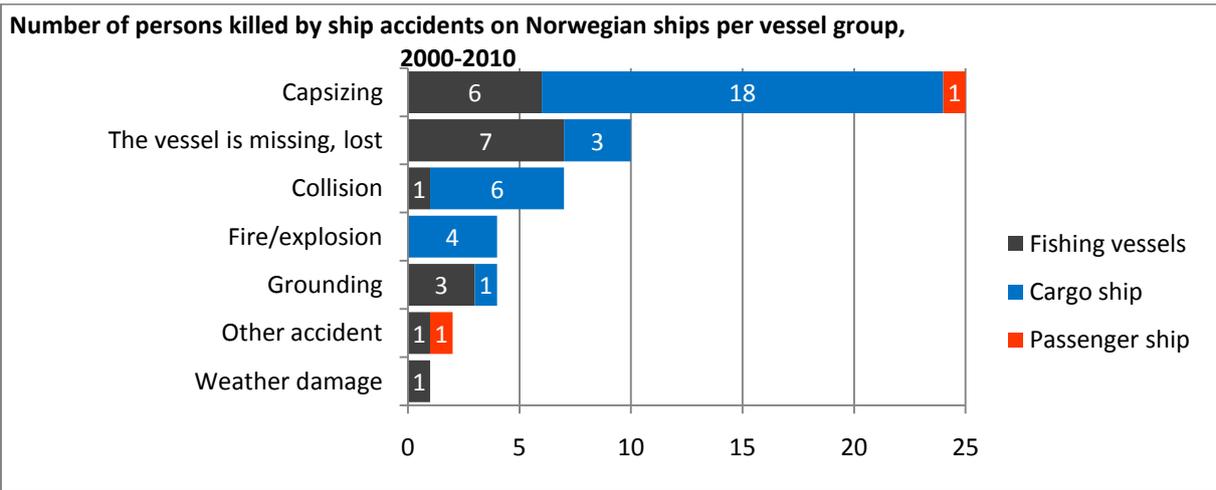
Three people were perished in 2010 as a result of ship accidents. Fatalities related to ship accidents has a historically strong connection with loss of the vessel. In 7 of 10 ship accidents involving fatalities, the vessel is lost.

Figure 2.4 Number of fatalities in ship accidents on Norwegian ships per vessel group, 2000-2010

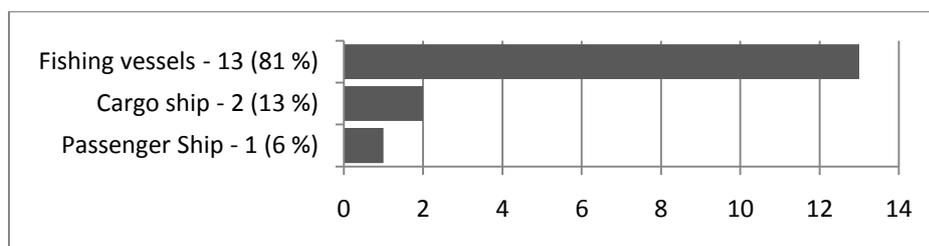
In 2000-2010, 3 out of 4 lost ships was a fishing vessel. However, it is worth noting that there were approximately 5,400 active fishing vessels in 2009, and that this is about twice the total number of cargo and passenger ships.

Figure 2.5 Number of lost ships in 2010 by vessel group

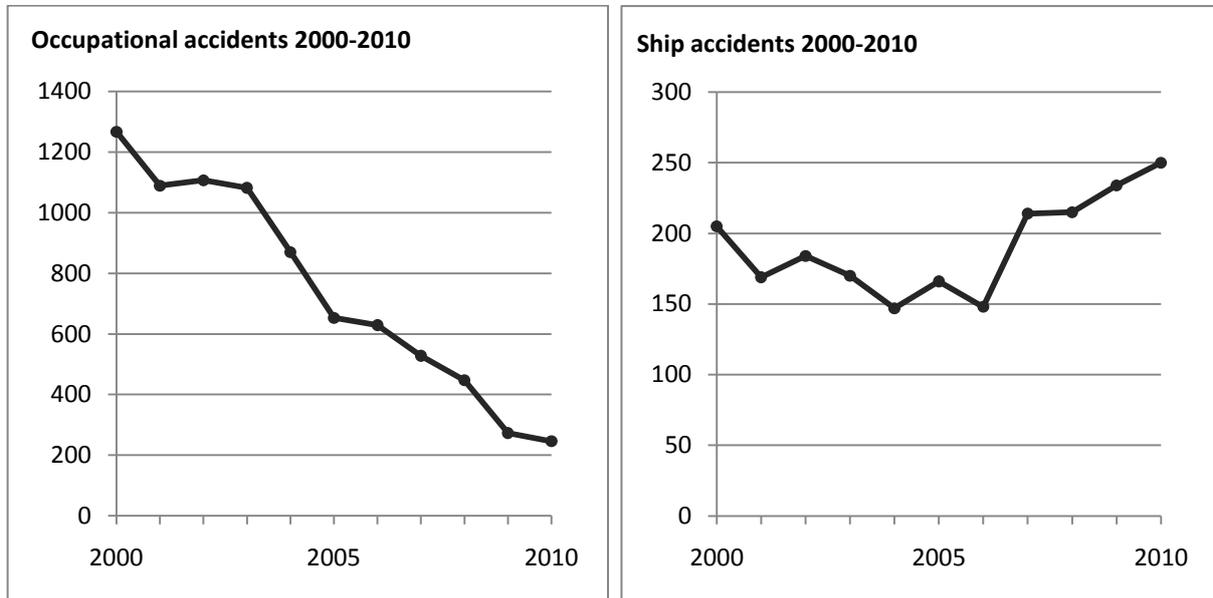
Figure 3.1 Number of occupational accidents and ship accidents for all ships (Norwegian and foreign flag)

Occupational accident means accidents affecting persons who work on board. Occupational accidents involving others on board, such as passengers and pilots, are also reported and included in the same statistics. Injuries to crews that happen as a result of a ship accident are not included in the figures in Figure 3.1. Very few accidents on foreign vessels in Norwegian waters are reported and recorded.

Figure 3.1 on ship accidents shows both Norwegian and foreign vessels⁴. The contribution from foreign vessels is mainly tankers. See Chapter 6 for further information.

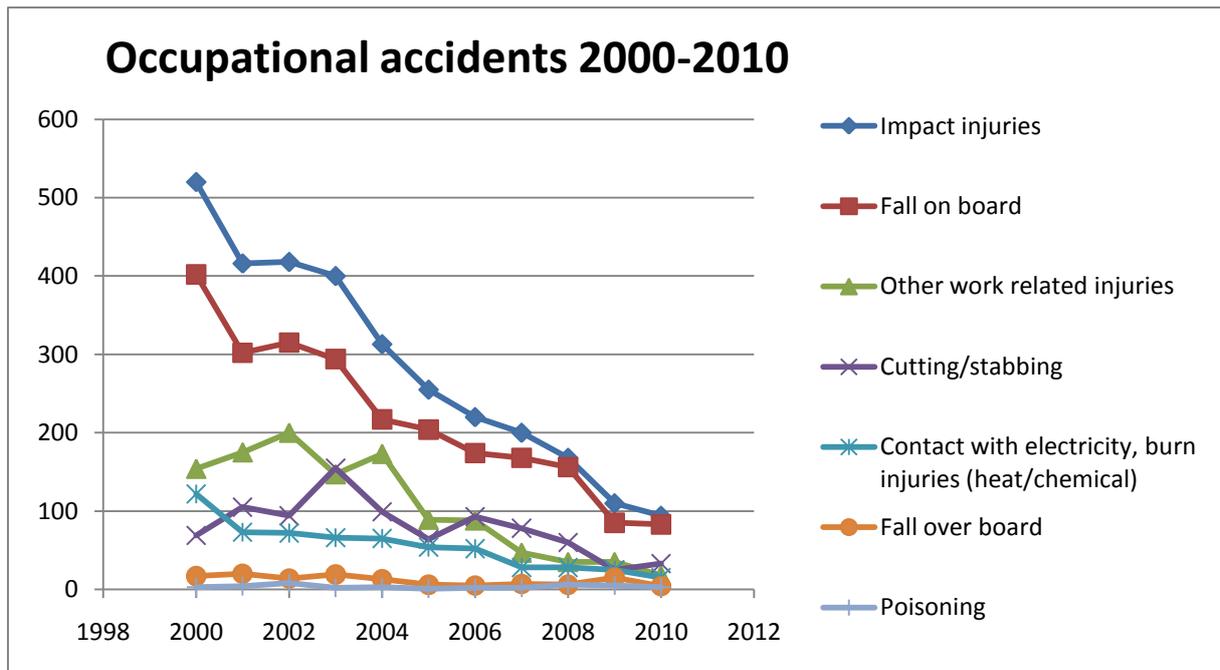
Figure 3.2 shows that there has been a positive development for all categories of occupational accidents in 2000-2010. Throughout the period, impact and crush injuries and falls on board were the most frequent types of accidents.

Figure 3.2 Number of occupational accidents 2000-2010 by category/cause

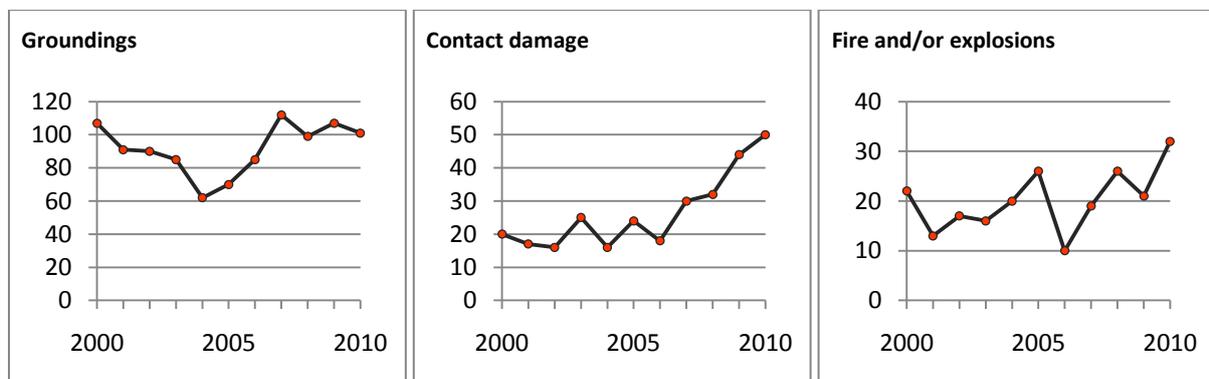
The increase in ship accidents occurred mainly due to an increase in the number of groundings and contact damage. We see from Figure 3.3 that the number of groundings in 2010 was 101 and that there have been more than 100 groundings each year since 2007. Contact damage has increased sharply from 18 in 2006 to 50 incidents in 2010. But other types of accidents have also shown a negative trend. As at 2010, fire and/or explosion is the third most frequent type of accident which often leads to the loss of the vessel. This is especially true of fires on smaller fishing vessels.

Figure 3.3 shows the trend in the number of accidents per accident type during the period 2000-2010. Grounding means any contact between the vessel and the seabed. No distinction is made between grounding or ground contact. Grounding is recorded as an accident even when damage to the vessel is very limited.

Contact damage is defined as incidents in which the vessel collides with a pier or other fixed installations. A collision is defined as an incident in which the vessel collides with another vessel or floating object.

Figure 3.3 Groundings, contact damage and fires and/or explosions in the period 2000-2010

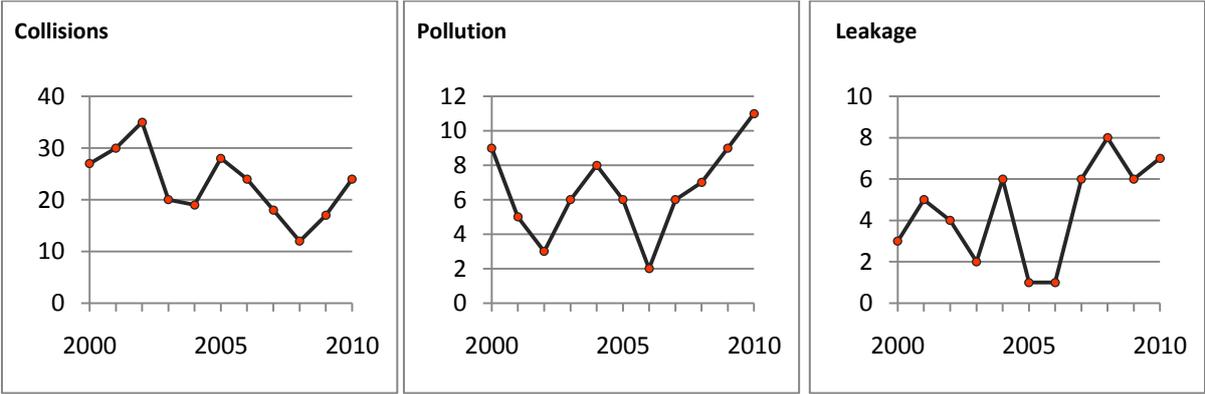
Figure 3.4 shows the number of collisions between vessels. In 2010, 24 collisions involving 44 vessels were recorded. A collision is defined as a single accident event even if it involves multiple vessels. All the involved vessels are recorded with the causes and consequences for each vessel's situation.

The accident type pollution is used when the primary incident is a discharge, for example, when a tank is overfilled. Pollution arising from an accident, such as grounding, is not included in Figure 3.4.

A leak means an intrusion of water that could cause a vessel to sink. Although leakage is an infrequent type of accident, nearly half of the 49 recorded cases in 2000-2010 led to the loss of the vessel.

Figure 3.4 Collisions, pollution and leakage, 2000-2010. The number of collisions reflects the number of collisions and not the number of vessels involved.

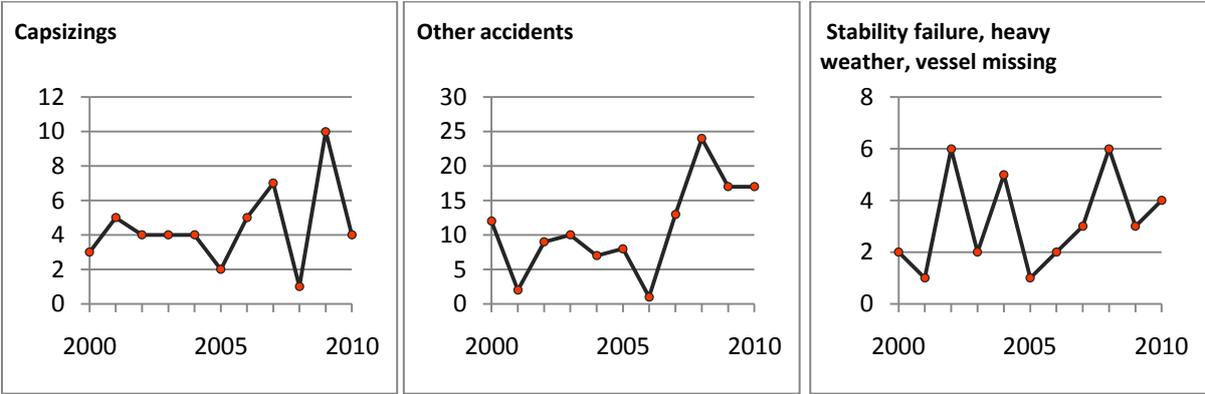
Many of the most serious accidents in the last 10 years have been capsizing accidents (see Figure 3.5). In 2000-2010 capsizing accidents accounted for 1/3 of fatalities connected with ship accidents. Most capsizing accidents happen on fishing and cargo ships of less than 3,000 BT.

Examples of incidents that have been recorded as other accidents in Figure 3.5 are ropes in propellers, collisions between cars on car ferries, lifting accidents and suspension deck malfunctions.

The accident categories stability failure, heavy weather damage and vessel missing occur rarely and are combined in Figure 3.5 .

Figure 3.5 Capsizing, other accidents and stability failure/heavy weather/vessel missing

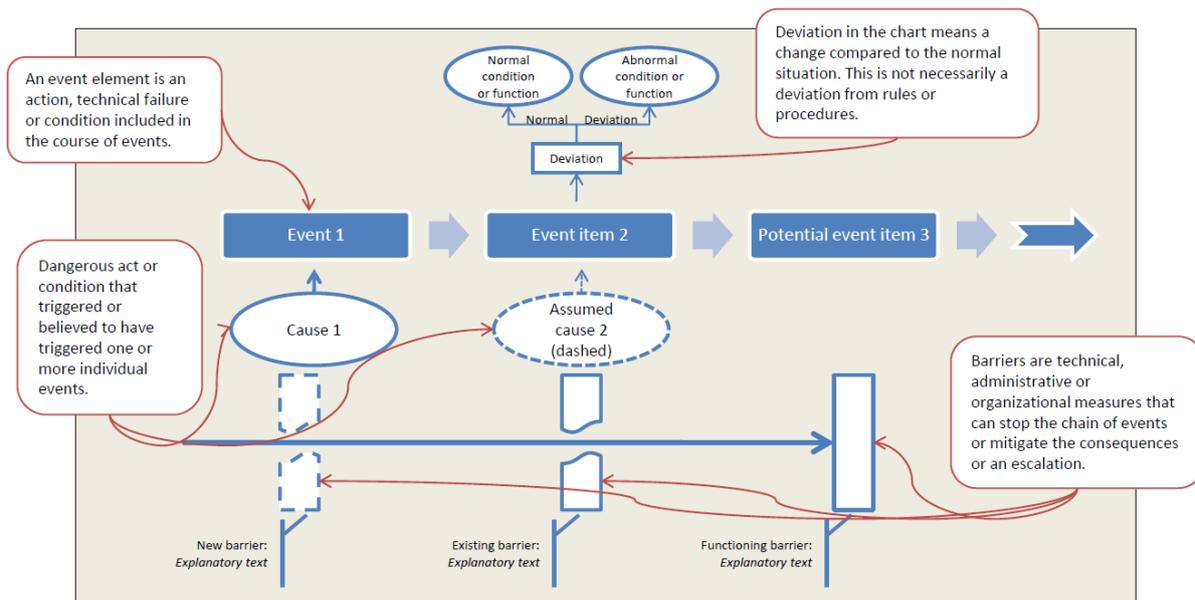
Figure 3.6 Incident and causal analysis. NMD analyzes accidents, among other things, on the basis of *Guidelines for the implementation of MTO analyses*. (Bento, 2001).

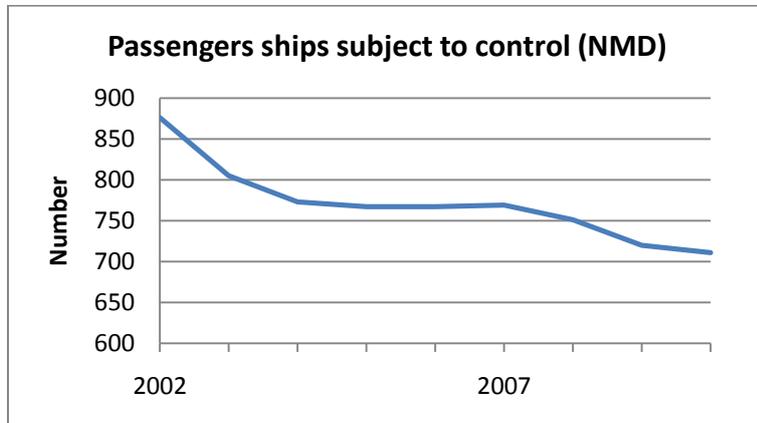
There was a decline in the number of passenger ships subject to control in the period 2002-2010. At the beginning of 2011 the Norwegian passenger ship fleet consisted of 711 ships. All passenger ships that carry 12 or more passengers are subject to control.

Figure 4.1 Passenger ships subject to control (NMD)

Figure 4.1 shows a marked decrease in the number of passenger ships subject to control in the same period. From 2006 to 2009, traffic on ferries measured by number of ferry crossings decreased by 3%. (Vegdirektoratet, 2009) (Directorate of Public Roads, 2009).

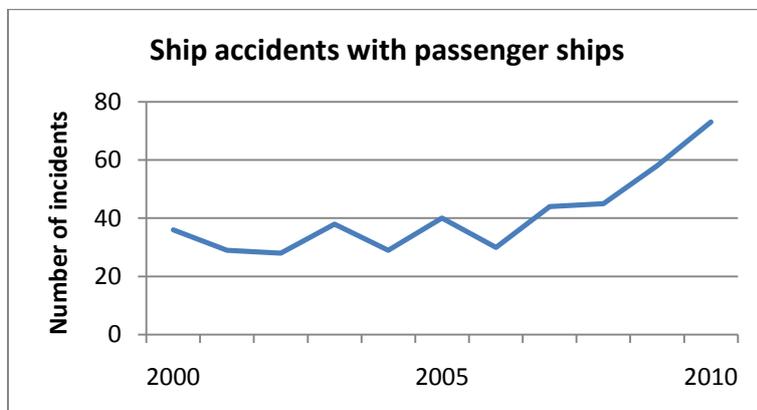
A steady increase in ship accidents involving passenger ships has been recorded since 2006. The main contributor to this increase is domestic car ferries, in which contact damage with ramps is the most common accident type. In 2010, a total of 73 accidents, an increase of 25% compared to last years numbers, were recorded.

Figure 4.2 Accidents with passenger ships 2000-2010

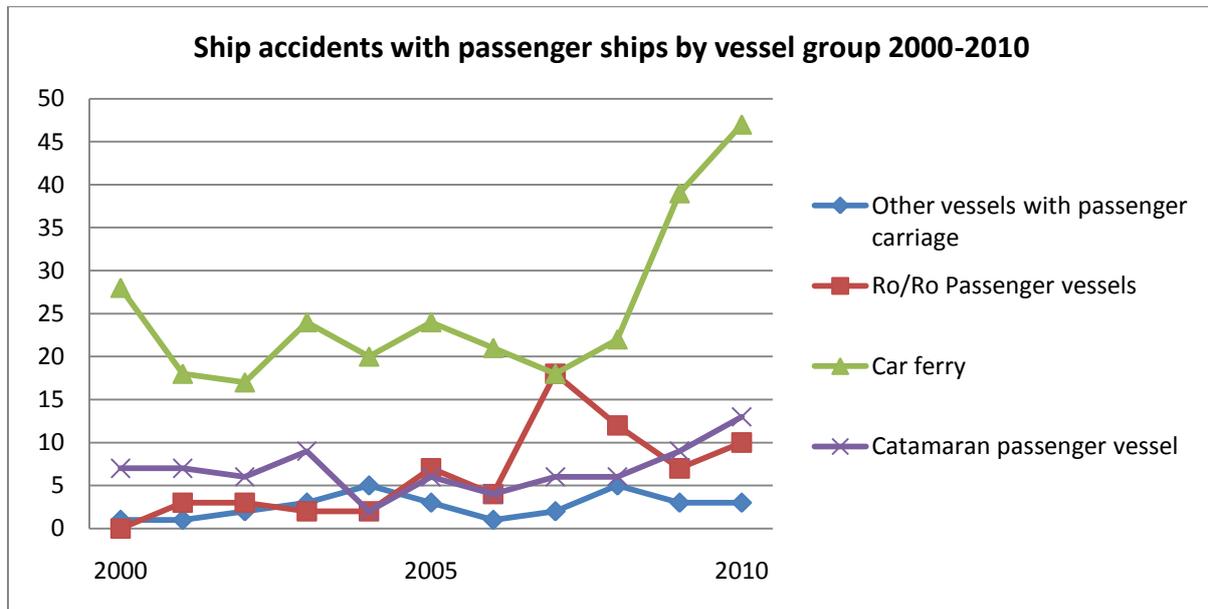
By classifying all passenger ships into four main categories, we see that car ferries are the biggest contributor to the increase (see Figure 4.3).

Figure 4.3 Accidents with passenger ships by vessel group, 2000-2010

Car ferries are defined here as ro-ro⁵ ships that are part of the road network in domestic trade. Ro-ro passenger ship means other ro-ro passenger ships in both domestic and foreign trade. Examples include Hurtigruta, Color Line or Fjord Line vessels. Catamaran passenger vessels are mainly high-speed vessels, but also catamaran passenger vessels that do not meet the requirements for status as a high-speed vessel. The rest of the types of passenger ships are collected in the group "Other passenger-carrying vessels." This can typically be smaller shuttle boats or other similar vessels such as medical and ambulance vessels.

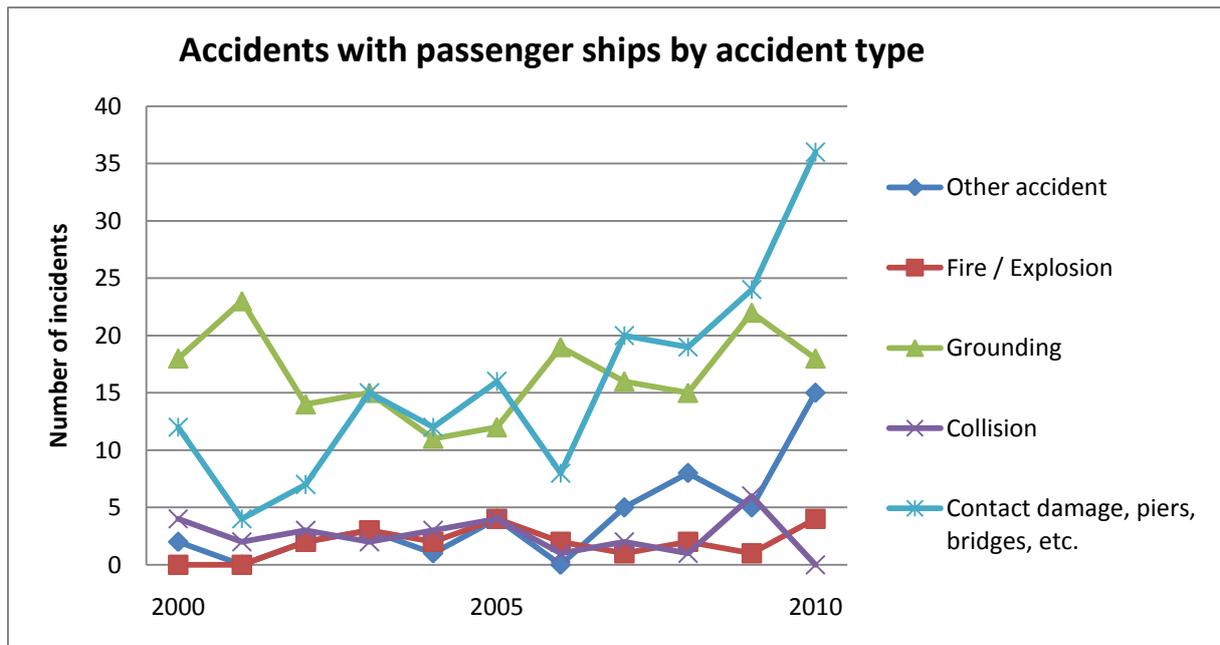
Contact damage and groundings are the most common types of accident that occur on passenger ships. The category "other accidents" below includes several subcategories, each of which does not provide statistical value. Contact damage with piers is the type of accident that has increased the most in the last five years (see Figure 4.4). A collision with ramps, or grounding in the immediate vicinity of the ferry landing that causes damage to equipment or injury to crew members, counts as contact damage. Contact damage mainly results in property damage. The incidents are usually not serious, since speeds are low. Accidents often cause the ferry service in question to close for a period and that the vessel has to be brought to a shipyard for repairs. In some cases minor injuries result from the collision.

Figure 4.4 Accidents with passenger ships 2000-2010 by accident type

Statistics in Figure 4.4 show that contact damage with car ferries is the type of ship accident that is increasing the most. After reviewing all contact damage cases involving car ferries the last three years, technical failure was identified in approximately 40% of the incidents, while human factors

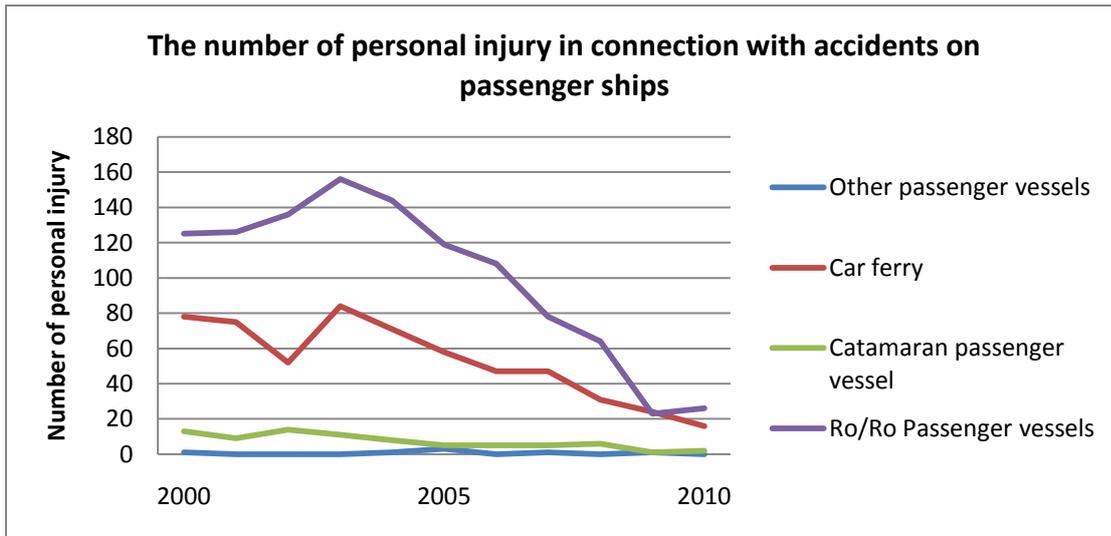
Figure 4.5 Number of injuries, all passenger types

Ro-ro passenger ships have the highest number of recorded injuries. This may correspond with the number of crews and passengers that the large foreign vessels have on board (see Figure 4.5).

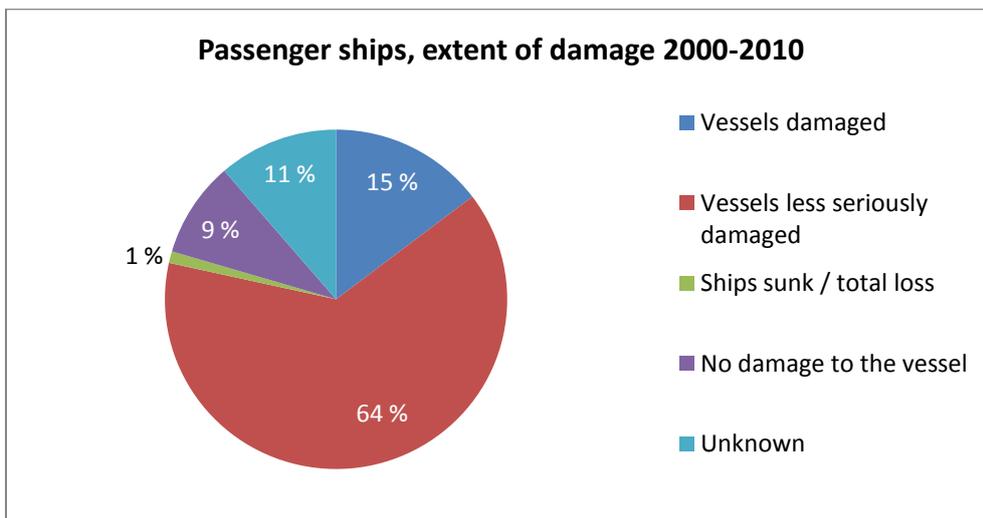
Figure 4.6 shows that 73% of all accidents with passenger ships result in none or minor damage to the ship.

Figure 4.6 Extent of damage, all passenger types, averaged over the period 2000-2010

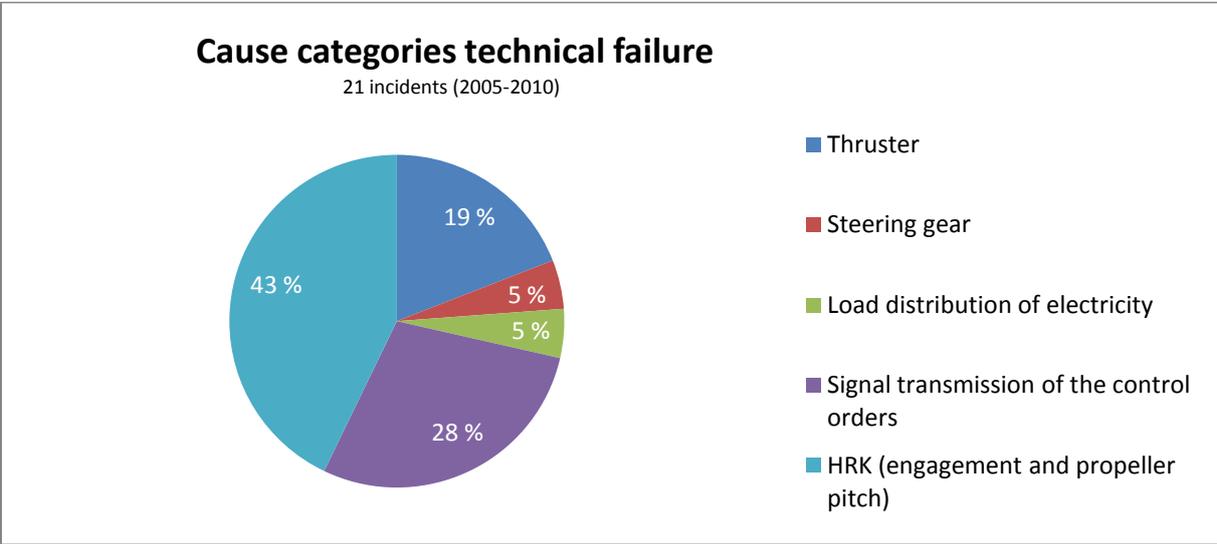
triggered the event in the remaining 60%. A study of the causes was carried out in connection with the recorded increase in these types of accidents. The causes are categorized and presented in Figure 4.7 and Figure 4.8.

Figure 4.7 Cause categories, technical failure on ferries

Technical failure is identified as a direct trigger of about 40% of the cases. Often, the components that fail are not identified as critical components. They are not covered by the vessel's maintenance system, and thus have no documented maintenance history. It also appears that the arrival phase is underestimated in terms of risk.

The hydraulic reversing gear for engaging the propeller and changing the propeller pitch, often called "HRK" (in Norwegian), is with its associated components directly involved in about 43% of contact damage incidents. The system is used for two important actions upon arrival, and should therefore be emphasized as critical in the maintenance system and covered by a special technical inspection. Cases have been recorded in which vessels increase their speed after engaging the forward propeller because the propeller pitch is locked. This has caused contact damage with piers, although the vessel initially had a low enough speed to be able to stop using only the aft propeller. Such a situation usually causes the main engine to overload and stop.

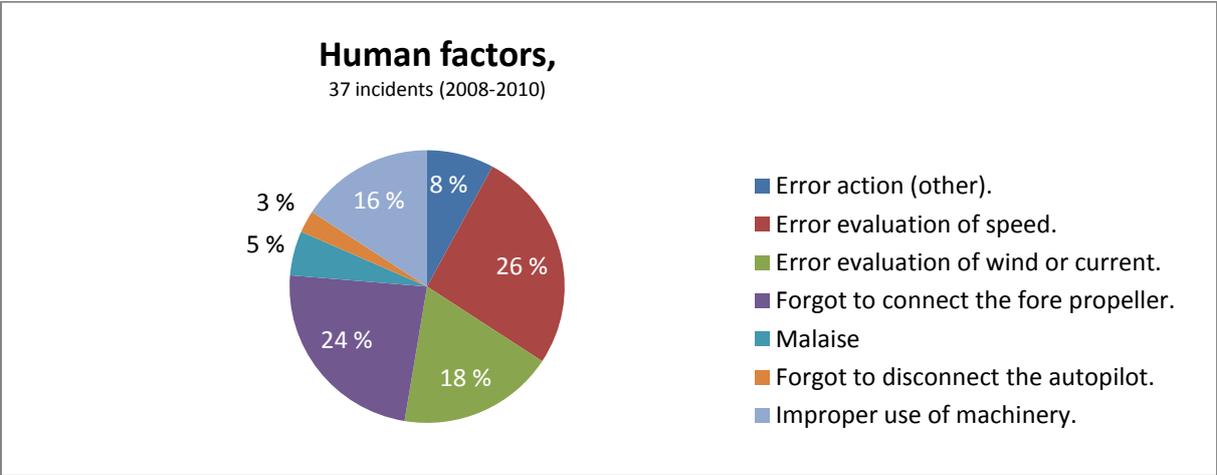
Figure 4.8 Human factors categorized with respect to identified causes

When a technical error occurs, the emergency operation systems found on the bridge are not always used. While there are various reasons for this, there is often a lack of system understanding, training and practice. Fault condition drills are not held often enough, and the drills that are carried out often focus on the same fault condition every time.

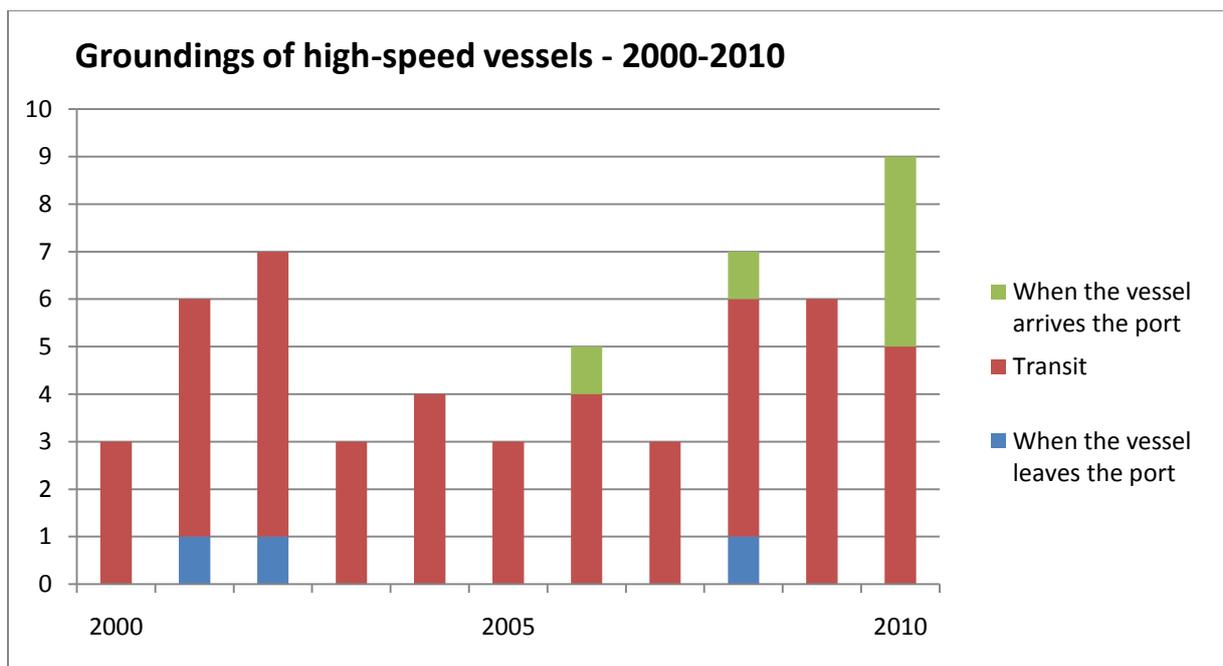
In 2010, NMD recorded 9 groundings (Figure 4.9). Four of the incidents occurred while the vessel was en route and at relatively high speeds. On 13 December 2009 the high-speed vessel "Helgeland" collided with a navigation marker. The accident is an example of a potentially large accident. Elements that were central to the AIBN's investigation were risk assessment with regard to high speed, critical operation, navigation with high requirements of navigators, voyage planning, communication and collaboration on the bridge. The AIBN's report after the accident was published in November 2010, with two safety recommendations to the ship-owner. (Statens Havarikommisjon, 2010) (Accident Investigation Board Norway, 2010)

Figure 4.9 Groundings of high-speed vessels 2000-2010

While the causes of the various incidents are different and complex, it is often small deviations from the norm that trigger the event. Faulty navigation is the most frequent precipitating cause of the groundings.

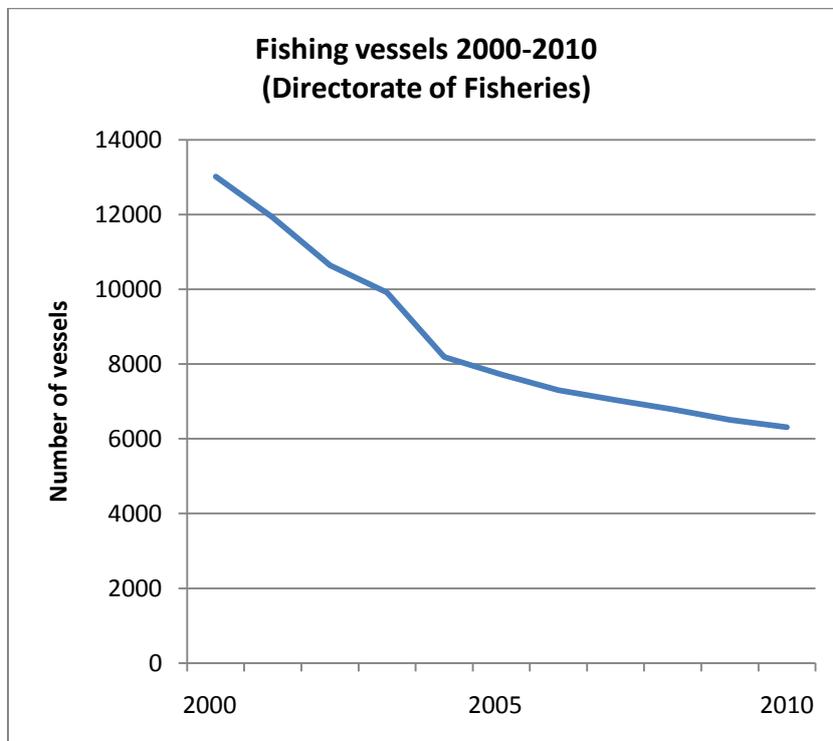
There has been a major decline in the number of registered fishing vessels in the period 2000 to 2010. Figure 5.1 shows a reduction in the number of vessels from 13,017 in 2000 to 6,311 in 2010.

Figure 5.1 Number of fishing vessels 2000-2010.

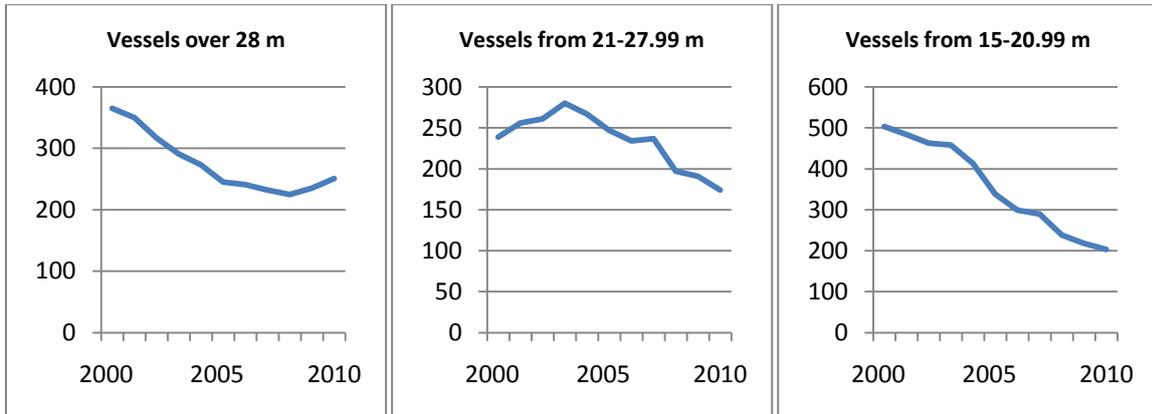
For vessels over 28 m and the 10 to 10.99 m group the trend turned in 2008 and the number began to rise again (see Figure 5.2 and 5.3).

Figure 5.2 Number of fishing vessels of 15 m and above in the period 2000-2010.

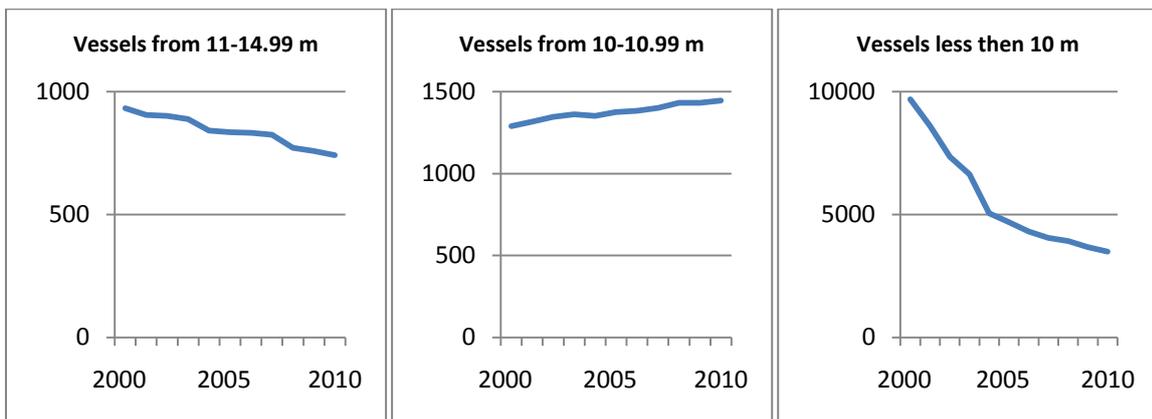
For vessels less than 10 m, the decline was particularly large. The number of registered vessels here more than halved during the period, from 8,611 in 2001 to 3,496 in 2010 (see Figure 5.3).

Figure 5.3 Number of fishing vessels under 15 m 2000-2010
